Thorne Bay  
Unit 8-1 (Southern half of unit only)  
15 September 1978

Unit  
8-1  
179.8 Ac.

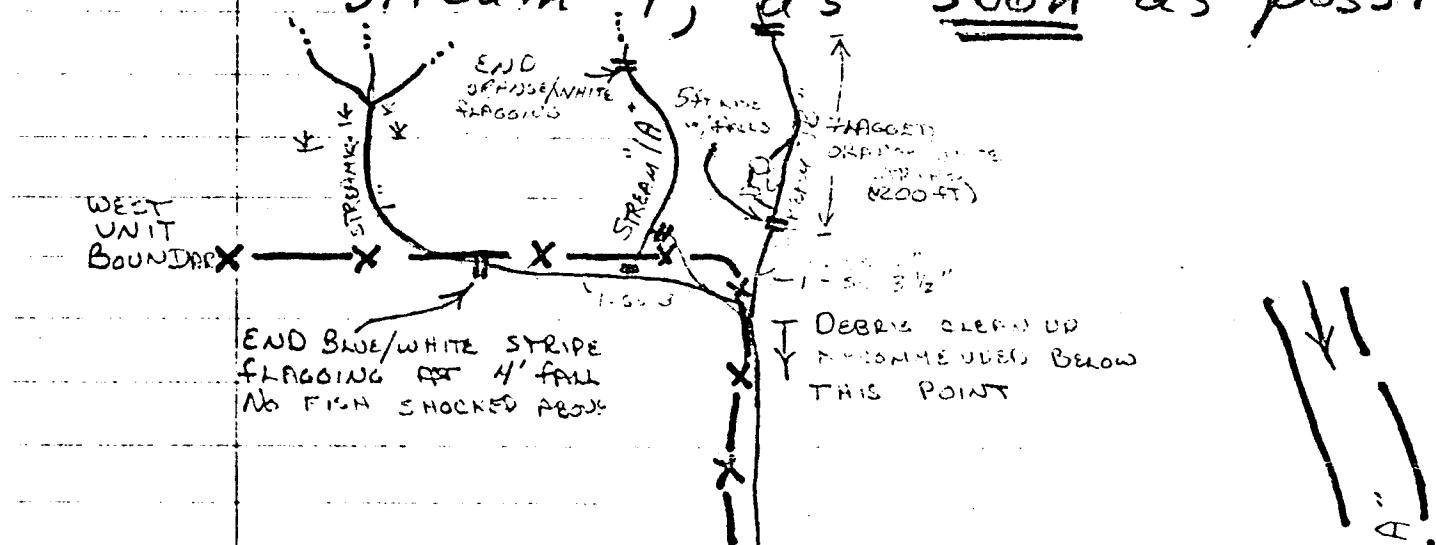
2 Coho, 1 Dolly Varden, and 1 Cutthroat were shocked below the unit boundary. 4 Coho were shocked within the unit. Excellent Coho rearing habitat within unit and beneath the unit until a 4 ft. falls presents a barrier. All Coho habitat was tagged and flagged blue and white.

Note: Recommend slash and debris cleanup for the 400 ft. of flagged habitat within the unit, just below where stream #1B intersects Stream #1, as soon as possible.
